The Anthropization of the Tirana-Durra Region Case Study: Former Durrës Swamp

Armela Reka

Polis University, Bylis St. 12,
Tirana, Albania

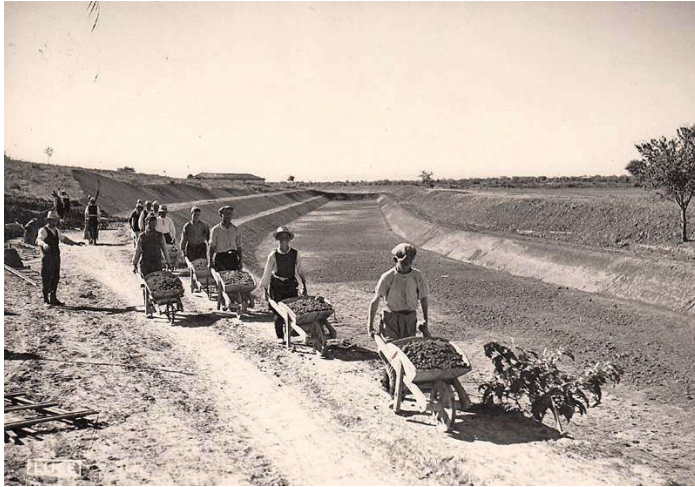
Fig1.2 Swamp reclamation - 1940

In 1944, the drafting of the plan for draining the marsh began. In 1962, the marsh was no more: a powerful embankment was built at the Dajlani Bridge, preventing the sea from entering. The road was built on the embankment, which exists to this day. People still know that place as Dajlan Bridge, for now there is no bridge there. A similar embankment was also built in Porto Romano, blocking the entrance of the sea from the north. The water was removed and a wide area of land was obtained. The intention was to use it for wheat, but the soil turned out to be so salty that the only product that could be grown there was beans.

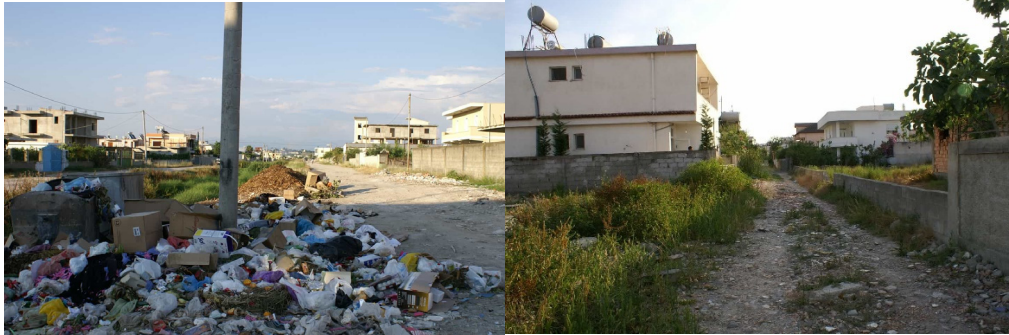
Fig 1.5- 1.6 Current state of the area

Although this area is being urbanized every day more and more different problems prove that the swamp has not disappeared. It is the health and environmental factors that prove the “existence of the swamp”. Garbage, open drains,

lack of containers, bad smell in the air and roads covered with gravel, potholes in places. It is this panorama that appears in many streets, squares and alleys. The canal passes through some parts of this neighborhood, in some of its streets, and it is the problem of the day for the residents. The inner streets of the neighborhoods are in complete darkness, there are no green and illuminated public spaces.

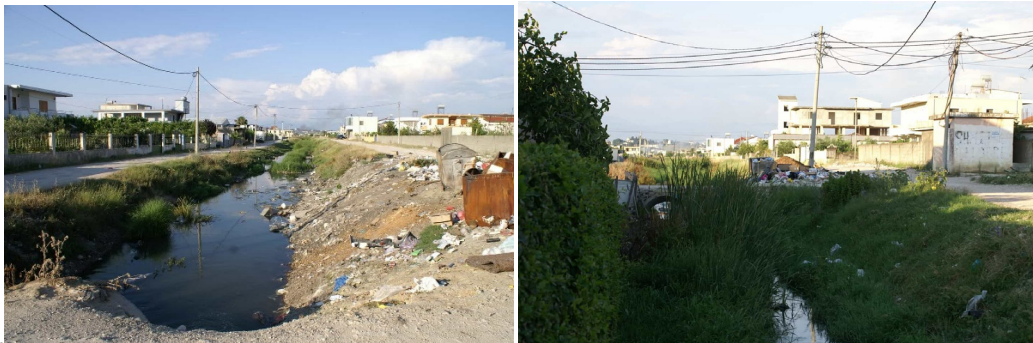
Fig 1.7- 1.8 Current state of the area

Another problem that comes after the main issues is the way of life. For more than 25 years, residents have been living among sewage. The area is crossed by an open canal which is a factor in the creation of various infectious diseases. Statistics show that numerous cases of residents affected by various infectious diseases have been registered and the most affected age group is that of children.

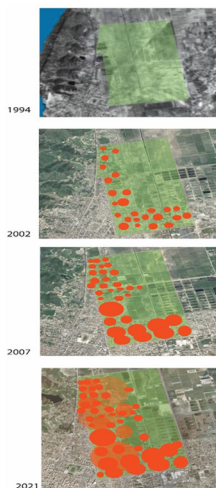
Fig 1.9 Process of anthropization

Using geospatial techniques, we see that the magnitude of human development activities affects plant cover. The results of the analysis show a remarkable impact of anthropization.

Uncontrolled demographic movements caused them to move from the South to the North in a land that was designed for agricultural land that used to be a marsh and nowadays "Durrësi Ri" is found. The area continues to be known as the "Durrës Swamp" but there is no free land anymore, as we can see in the picture.

Urbanization has occurred with rapid steps in this area, changing the land use cover and its function

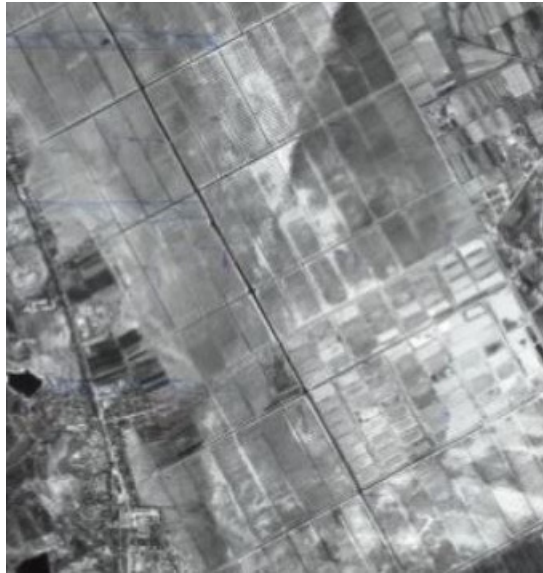
Fig. 1.10 Homogenization

- 1) In the 1960s we have water baths, completely intact.

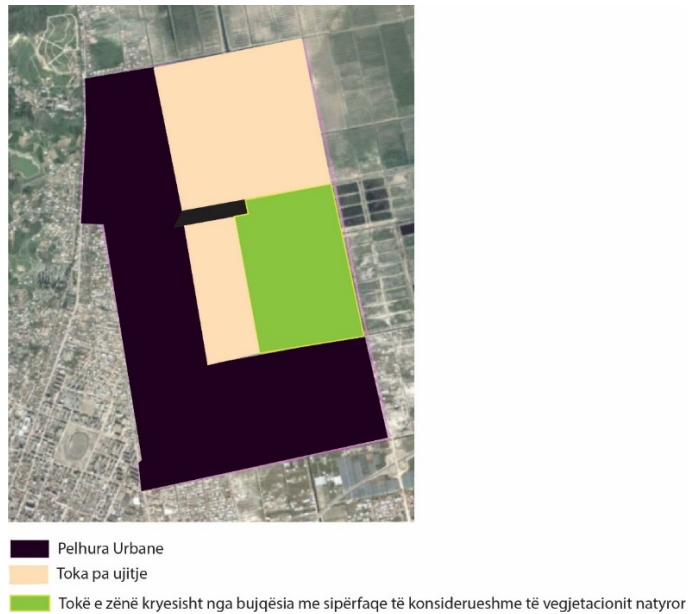
Fig 1.13 Land Cover

In order to compare and see how high and with how fast urbanization has occurred, we have carried out some measurements as below:

-Total area of the study area = 5.75 km²

-Surface of the unbuilt area = 2.32 km²

-Surface of the area built in 1994= 0.0614 km²

-Surface of the built area in 2021 = 3.35 km²

Relative Change = $\frac{\text{Sip. 2021} - \text{Sip. 1994}}{\text{Sip. Total} - \text{Sip. not built}}$
= $\frac{3.35 - 0.0614}{5.75 - 2.32}$

= **0.958**

So relative change is bigger than 0.5.

From the calculations of the relative absolute change in different periods 1990-2021, we see that the relative change is 0.958. This value expresses the state and progress of urbanization, since the absolute relative change was

greater than 0.5, this indicates that urbanization is high.

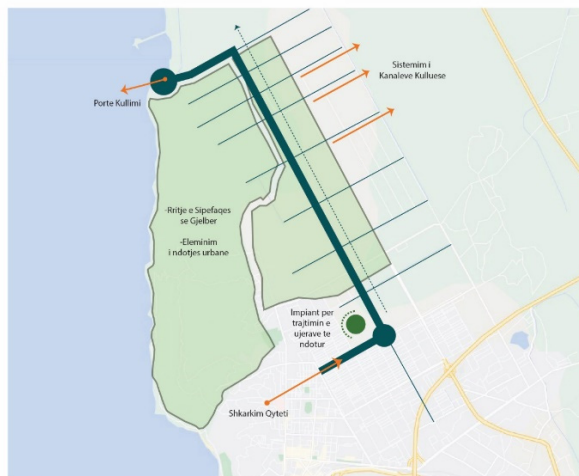
Fig.1.19 Scenario II- Water treatment plant, Source: Prepared by the author

Second scenario: Water treatment plant and naturalization of the area.

This scenario proposes the placement of a sewage treatment plant near the point where the city's water is discharged, which then continues to the drainage point in Porto Romano. Other interventions that are proposed are the rehabilitation of drainage canals, increase of the green surface, in this way urban pollution is also eliminated.

Skenari II- Impiant i trajtimit te ujerave- Natyralizim
