**Prof.Dr. Sherif Lushaj, Prof. Dr. Vezir Muharremaj, Artan Kacani**

**SHKUMBINI RIVER AT THE ENDING FLOW THE  
RROGOZHINA BRIDGE - RIVERMOUTH, DEGRADATION AND  
PROTECTION**

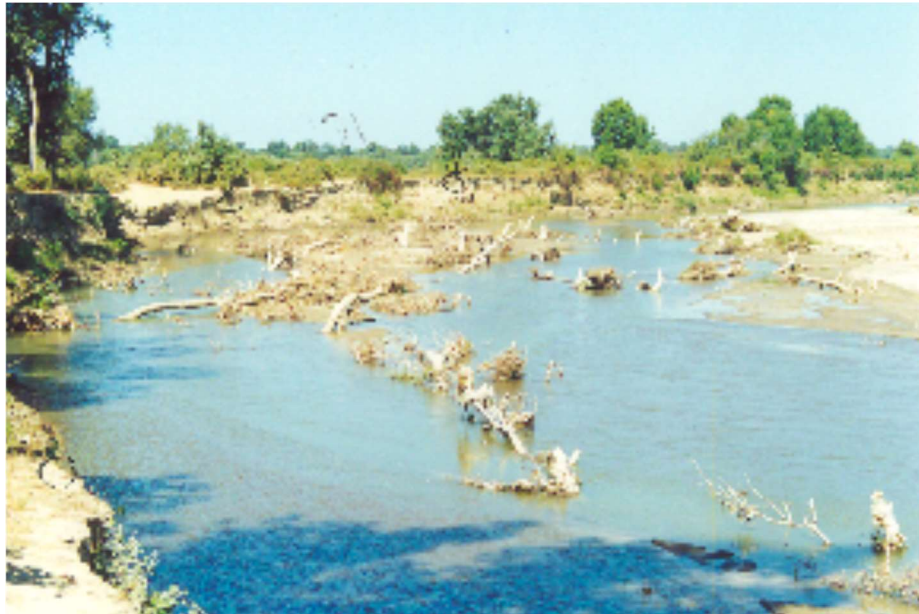
*Photo no : Shkumbin river erosion*

**River erosion.** Along all the river segment under study from Rogozhina Bridge to the Rivermouth can be observed the eroded, damaged or tending to be eroded banks. By 2002, there were identified around 105,000 m<sup>2</sup> of eroded soil. The most damaged part of the river is observed at the Cerma-Sulzotaj segment, while from Sulzotaj to the rivermouth the banks are more protected due to forest cover.

The main causes of erosion are: (i) gravel mining on river bed without any criteria and under the water mirror, opening deep holes (C.A. Troendle, 2002); (ii) collapse of the riverbanks in deep for filling the holes; (iii) the forest cover of riverbanks varies 41-50 %; (iv) partly funksioning of the drainage system; (v) mechanical composition of the soil, were prevails the sand and silt content on over > 80 %, decreasing the banks stability, as defined in 12 soil profiles on 0-30 cm, 30-60 and 60-90 cm depth. The authors write that; a landslide is a mass movement occorring on steep slopes under the action of gravity. Four types of mass movements can be

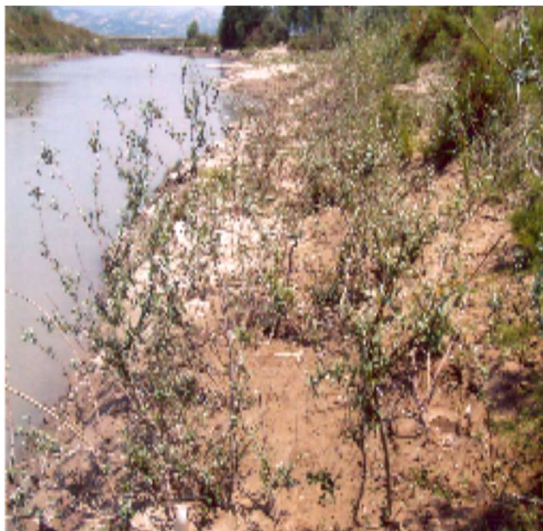
Photo no- reforestation of sediment deposit places  
the river

**2. Planting the sediment deposit places.** Throughout the length of the river, especially at the eroded places, sedimented surfaces are created, which can be planted with shrubs, mainly tamarisk. According to Owens,

From Rrogozhina Bridge to Bashtove, this process has created an area of about 73,500 m<sup>2</sup>, of which 57,000 m<sup>2</sup> can be planted with shrubs to increase riverbanks stability. In planting practice, the first belt will be planted with tamarisk, the second with willow and further with poplar. The first rows near the river are planted with reed, using rhizomes, then tamarisk and willow, planting with sprouts and further the poplar with sprouts in the deposit places and the reforestation with seedlings, densification of sparse forests and the creation of a protective forest belt.

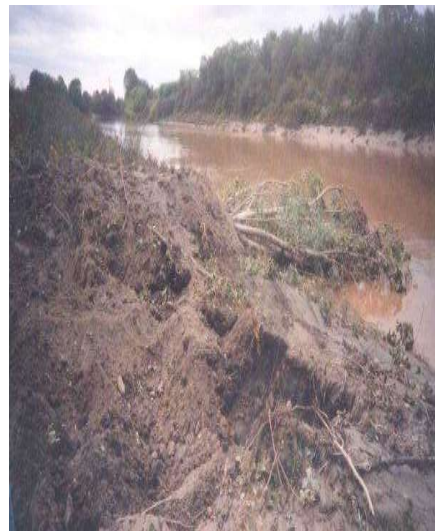
Photo no Planting tree trunks on

**4. Planting tree trunks with all plant mass.** Large poplar stems with all the plant mass are placed on the side of the river water line, when the depth is gradual (shallow) the bottom part is tied, while the trunk extends into the river. This limits the water speed, collects sediments by making a mass that stops erosion and serves as the ground where vegetation grows. In our country, this practice has been used for the first time in the Cerme pilot segment, while it is applied already in other countries (Stream Corridor Restoration).

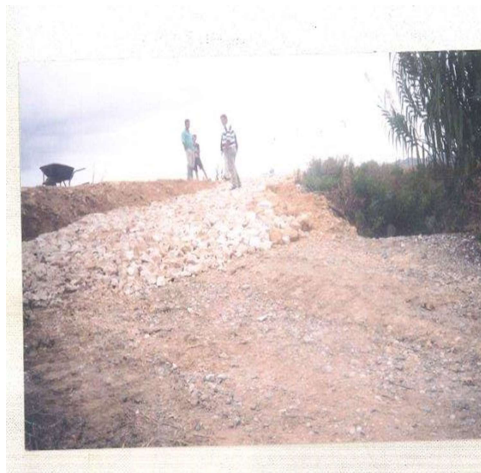
Photo no : embankments protection

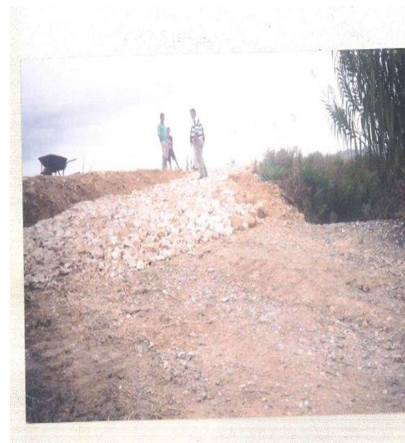
Photo: Placing stone belts

**5. Placing stone belts in the inner river escarpments.** Placement of stones at the banks of the river in the form of a cobble is an effective measure, especially on the riverbanks with a small slope and with a shallow bed near the bank. The stones are placed in belts of 1-2 m wide embedded in the ground, depending on the territory and on the slopes of the bank. The stone is covered by sediments, where aquatic plants survive and erosion is limited.
